**Flood Control Project Maintenance  
Levee Inspections****LMA District Cover Sheet  
Spring 2014 Levee Inspection Results****Reclamation District No. 0150 Merrit Island**

**Flood Control Project Maintenance  
Levee Inspections**

**Spring 2014 Levee Inspection Results**

**Reclamation District No. 0150 Merrit Island**

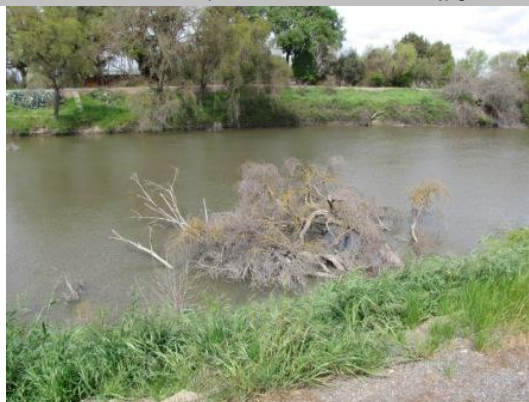
Photo 1 of 1 : pkazi\_s\_20140328\_637.jpg

LM Start	4.35	Rating **	N	Issue No.	37
LM End	4.35	Issue Type +	Ma	Location *	WS
Category	Earthen Levee			GPS Latitude/Longitude	
				Start	End
Item	Trim / Thin Trees			38.373319 °	38.373319 °
				-121.550836 °	-121.550836 °
DWR ID	DWR_RD0150_03_s _ 2012_37				
Action/Comments					
Tree stumps.

View of tree stumps on the waterward slope.

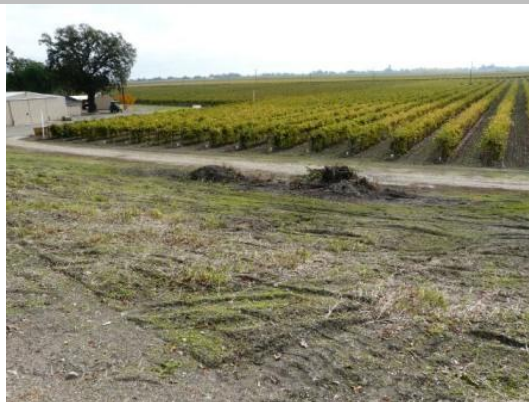
Photo 1 of 4 : pkazi\_s\_20140328\_650.jpg

LM Start	4.46	Rating **	M	Issue No.	51
LM End	4.46	Issue Type +	Ma	Location *	LS
Category	Earthen Levee			GPS Latitude/Longitude	
				Start	End
Item	Encroachments			38.374269 °	38.374269 °
				-121.549385 °	-121.549385 °
DWR ID	DWR_RD0150_03_s _ 2012_51				
Action/Comments					
Prunings

Remove pruning pile on landward slope at LM 4.46.

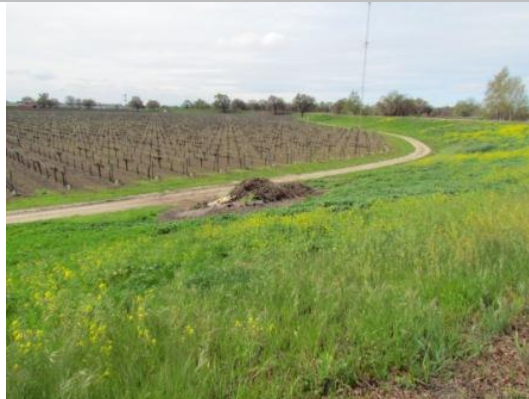
Photo 2 of 4 : pkazi\_s\_20140328\_651.jpg

Prunings were found on the landside of the levee looking downstream.

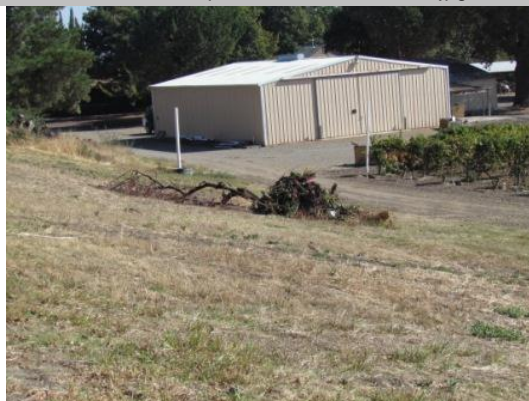
Photo 3 of 4 : pkazi\_s\_20140328\_652.jpg

Prunings were found on the landside of the levee looking upstream. This picture was taken during fall 2012 inspection.

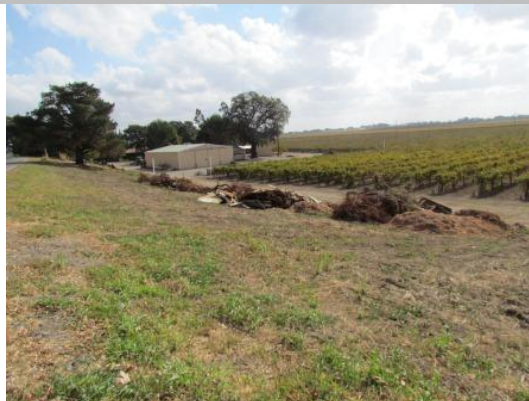
Photo 4 of 4 : pkazi\_s\_20140328\_653.jpg

Updated picture of the pruning pile on the landside of the levee looking upstream during the fall 2013 inspection.

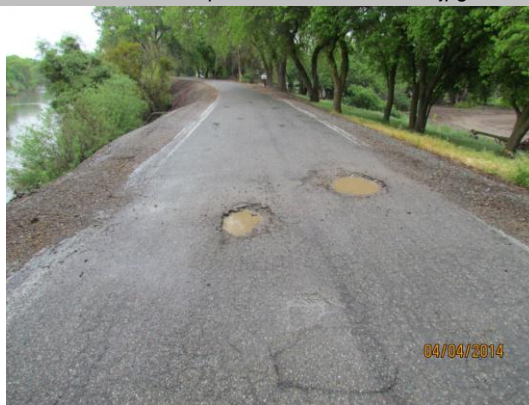
Photo 1 of 2 : pkazi\_s\_20140404\_078.jpg

Updated view of the crown depression during spring 2014 inspection.

LM Start	4.95	Rating **	M	Issue No.	65
LM End	4.95	Issue Type +	Ma	Location *	CR
Category	Earthen Levee			GPS Latitude/Longitude	
				Start	End
Item	Crown Surface / Depressions / Rutting			38.377333 °	38.377333 °
				-121.541930 °	-121.541930 °
DWR ID	DWR_RD0150_03_s_2013_65				
Action/Comments					
Add appropriate gravel or road base. Grade and compact.

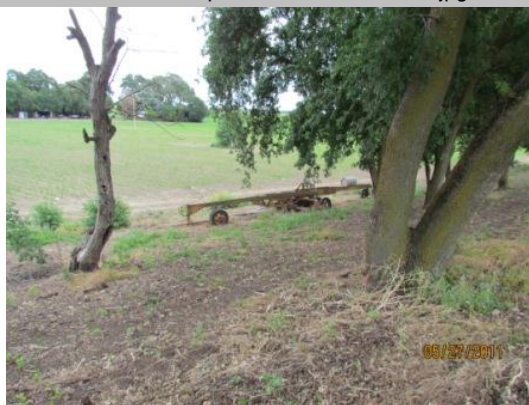
Photo 1 of 1 : pkazi\_s\_20140328\_614.jpg

LM Start	4.98	Rating **	M	Issue No.	9
LM End	4.98	Issue Type +	En	Location *	LS
Category	Earthen Levee			GPS Latitude/Longitude	
				Start	End
Item	Encroachments			38.377761 °	38.377761 °
				-121.541319 °	-121.541319 °
DWR ID	DWR_RD0150_03_s _ 2012_9				
Action/Comments					
Equipment

Equipment on the landside toe of the levee. The picture was taken from crown looking downstream.

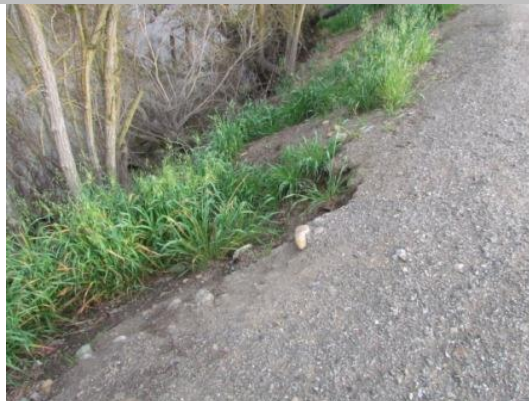
Photo 1 of 2 : pkazi\_s\_20140328\_610.jpg

Slope instability was found on the waterside of the levee looking upstream.

LM Start	5.13	Rating **	M	Issue No.	4
LM End	5.13	Issue Type +	Ob	Location *	WS
Category	Earthen Levee			GPS Latitude/Longitude	
				Start	End
Item	Slope Stability			38.379456 °	38.379456 °
				-121.540147 °	-121.540147 °
DWR ID	DWR_RD0150_03_s _ 2012_4				
Action/Comments					
Repair slope instability.

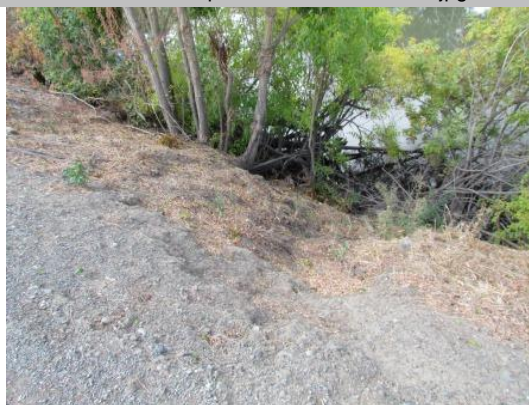
Photo 2 of 2 : pkazi\_s\_20140328\_611.jpg

Updated picture of the slope instability on the waterside slope of the levee looking downstream during the fall 2013 inspection.

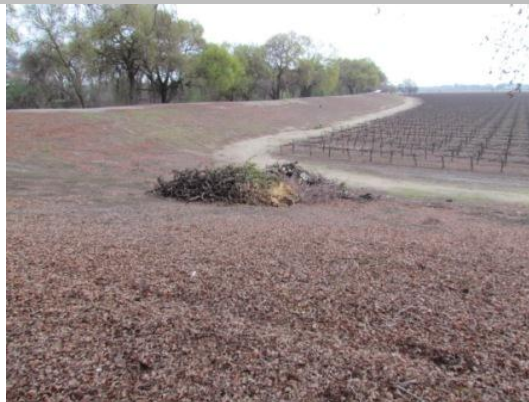
Photo 1 of 4 : pkazi\_s\_20140328\_616.jpg

Prunings were found on the landside of the levee looking upstream.

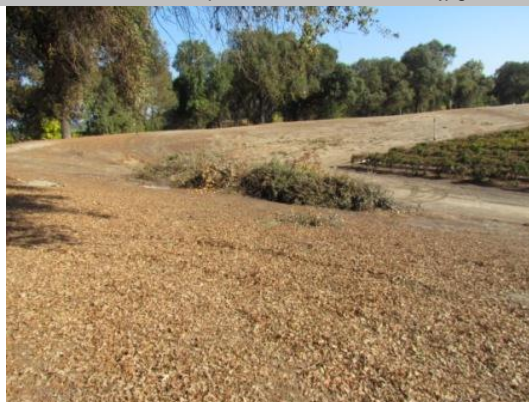
Photo 2 of 4 : pkazi\_s\_20140328\_617.jpg

Pruning was found on the landside toe of the levee looking upstream.  
This picture was taken during fall 2012 inspection.

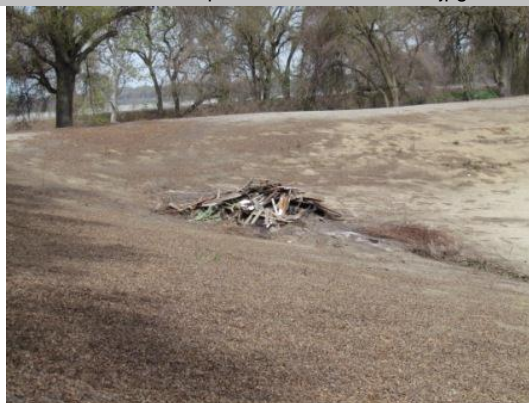
Photo 3 of 4 : pkazi\_s\_20140328\_618.jpg

Updated picture of debris and pruning on the landside toe of the levee looking upstream. This picture was taken during spring 2013 inspection.

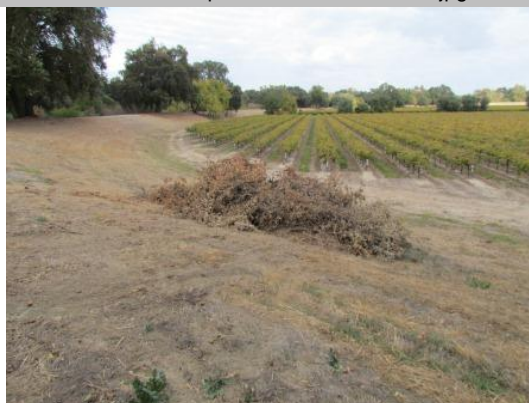
Photo 4 of 4 : pkazi\_s\_20140328\_619.jpg

Updated picture of pruning pile on the landside toe of the levee looking upstream during the fall 2013 inspection.

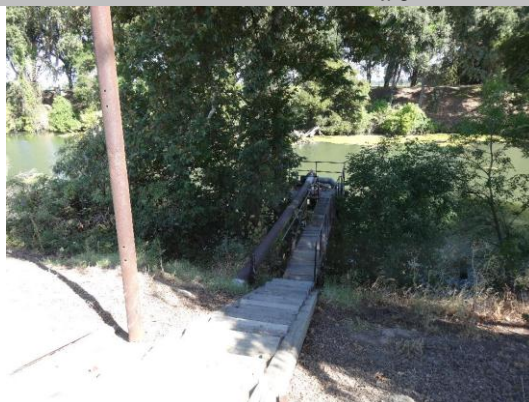
Photo 1 of 1 : UCIP\_5607.jpg

LM Start	5.81	Rating **	M	Issue No.	22
LM End	5.81	Issue Type +	En	Location *	WS
Category	Supplemental			GPS Latitude/Longitude	
				Start	End
Item	DWR UCIP Field Study			38.383996 °	38.383996 °
				-121.542638 °	-121.542638 °
DWR ID	DWR_RD0150_03_s _ 2014_22				
Action/Comments					
Inspector Comments: FS_ID:28265					
EP_NO: N/A					
Repair Type:					
Crossing Status:					
UCIP Comments: - levee toe cut out at open end of the pipe.service pole and control box on river bank.					
FIELD_STRUCT_DESC: 10-inch steel pipe through the levee, 7.8 feet below crown. Pump and gate valve on steel platform. Cross fence, wire drag gate. (Permit No. 1167, D. Conner) O&M Manual SAC 112, March 1957.					
FS Date: 8/23/2013

WS view: walkway, pipe, pump and support deck on river bank.

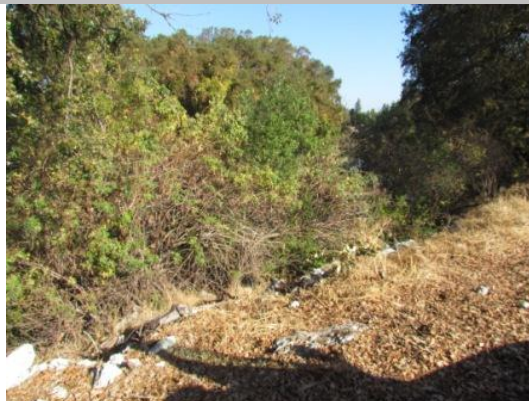
Photo 1 of 1 : pkazi\_s\_20140328\_628.jpg

Wild growth was found on the waterside slope of the levee looking upstream.

LM Start	5.88	Rating **	M	Issue No.	28
LM End	5.88	Issue Type +	Ma	Location *	WS
Category	Earthen Levee			GPS Latitude/Longitude	
				Start	End
Item	Vegetation			38.384333 °	38.384333 °
				-121.541310 °	-121.541310 °
DWR ID	DWR_RD0150_03_s _ 2012_28				
Action/Comments					
Remove the wild growth other than native grasses from the levee slopes.

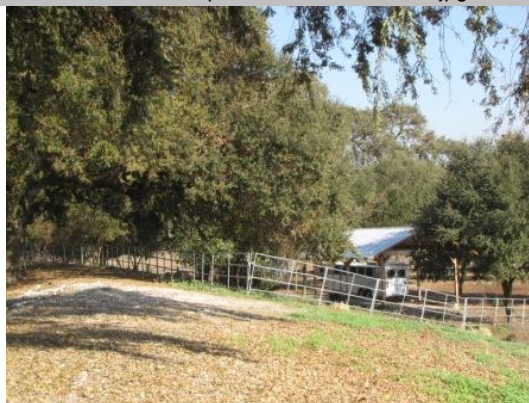
Photo 1 of 1 : pkazi\_s\_20140328\_656.jpg

View of fence around a horse pen along the shoulder of the levee and the landward slope.

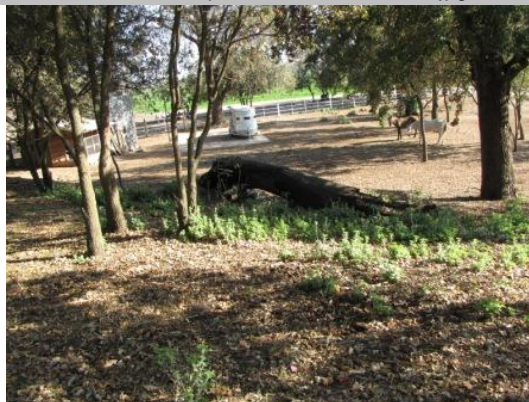
Photo 1 of 1 : pkazi\_s\_20140328\_657.jpg

View of a tree trunk lying on the landward slope blocking visibility.

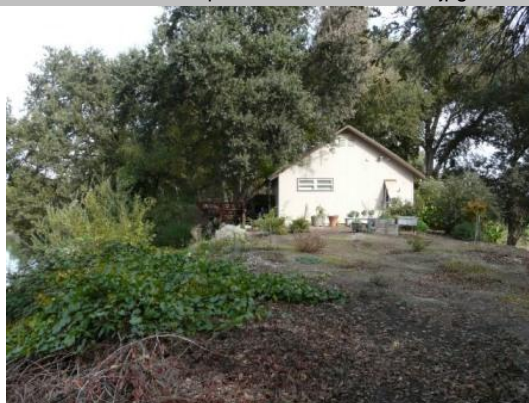
Photo 1 of 1 : pkazi\_s\_20140328\_658.jpg

Building &amp; associated landscaping on levee crown at LM 5.93.

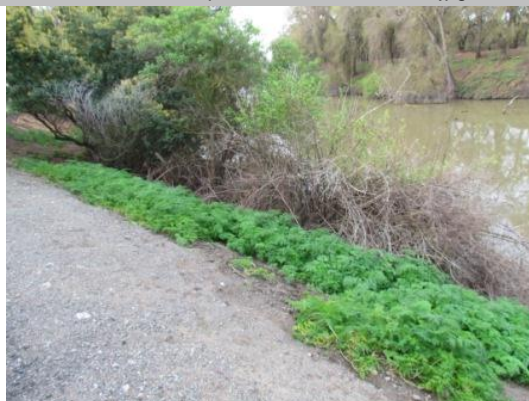
Photo 1 of 1 : pkazi\_s\_20140328\_633.jpg

Tree trunks and vegetation was obstructing the visibility on the waterside slope of the levee looking downstream.

LM Start	6.05	Rating **	M	Issue No.	33
LM End	6.05	Issue Type +	Ma	Location *	WS
Category	Earthen Levee			GPS Latitude/Longitude	
				Start	End
Item	Trim / Thin Trees			38.386351 °	38.386351 °
				-121.539828 °	-121.539828 °
DWR ID	DWR_RD0150_03_s _ 2012_33				
Action/Comments					
Thin trees to allow visibility of the ground and room to flood fight.

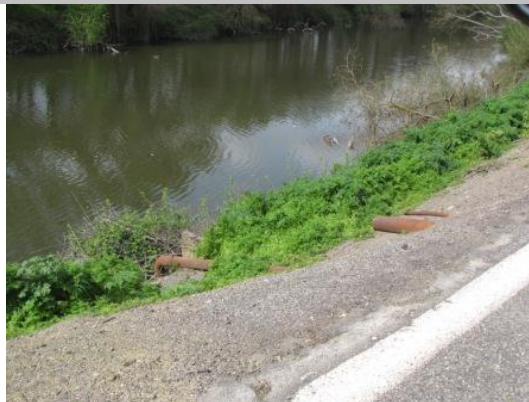
Photo 1 of 1 : pkazi\_s\_20140328\_642.jpg

LM Start	6.06	Rating **	M	Issue No.	46
LM End	6.06	Issue Type +	Ma	Location *	WS
Category	Earthen Levee			GPS Latitude/Longitude	
				Start	End
Item	Encroachments			38.386422 °	38.386422 °
				-121.539861 °	-121.539861 °
DWR ID	DWR_RD0150_03_s _ 2012_46				
Action/Comments					
Pipe					
Inspector Comments: Improperly abandoned pipe through the levee.

View of an improperly abandoned pipe through the levee looking upstream.

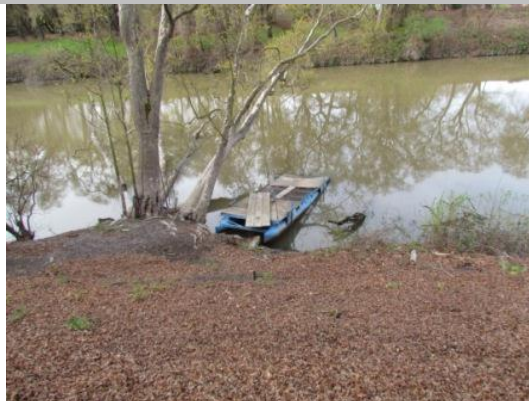
Photo 1 of 1 : pkazi\_s\_20140328\_641.jpg

LM Start	6.14	Rating **	M	Issue No.	44
LM End	6.14	Issue Type +	En	Location *	WS
Category	Earthen Levee			GPS Latitude/Longitude	
				Start	End
Item	Encroachments			38.387295 °	38.387295 °
				-121.540612 °	-121.540612 °
DWR ID	DWR_RD0150_03_s _ 2012_44				
Action/Comments					
Abandoned vehicles					
Inspector Comments: It appeared to be an abandoned dock.

An abandoned dock was found on the waterside of the levee looking upstream.

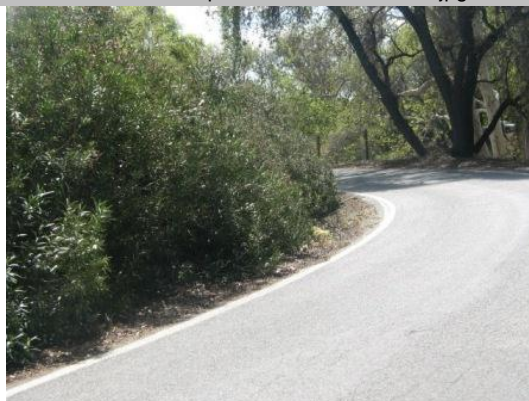
Photo 1 of 1 : pkazi\_s\_20140328\_625.jpg

Oleander on landward slope blocking view of levee from LM 6.24 to 6.32

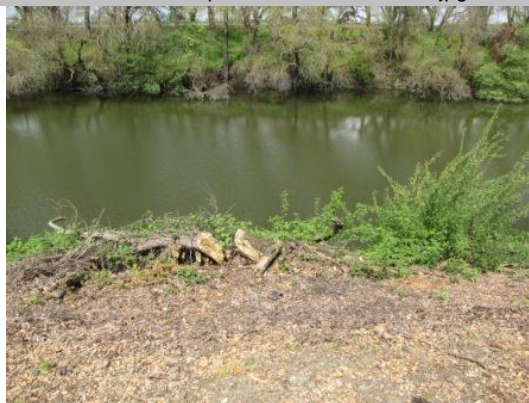
Photo 1 of 1 : pkazi\_s\_20140328\_647.jpg

View of tree stumps on the waterward slope.

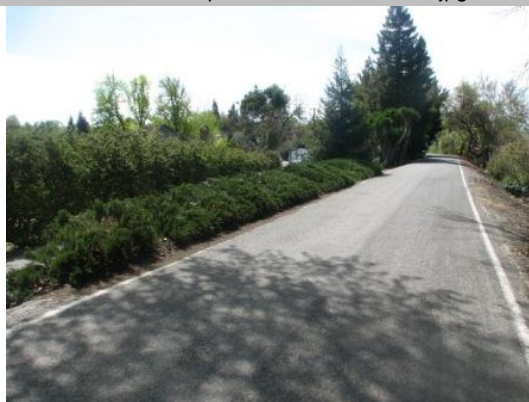
Photo 1 of 1 : pkazi\_s\_20140328\_626.jpg

Landscaping on landward slope blocking view from LM 6.37 to 6.40

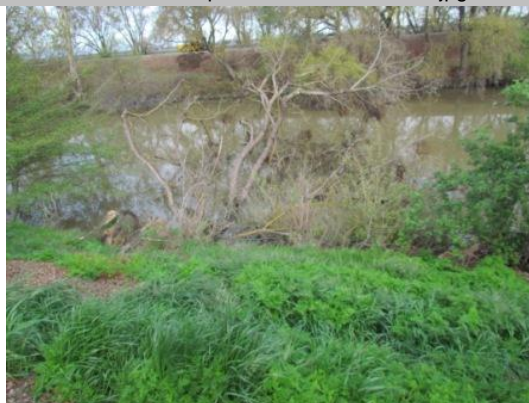
Photo 1 of 2 : pkazi\_s\_20140328\_665.jpg

Vegetation on the waterside of the levee looking downstream.

LM Start	6.49	Rating **	M	Issue No.	62
LM End	6.49	Issue Type +	Ma	Location *	WS
Category	Earthen Levee			GPS Latitude/Longitude	
				Start	End
Item	Trim / Thin Trees			38.390935 °	38.390935 °
				-121.539369 °	-121.539369 °
DWR ID	DWR_RD0150_03_s _ 2012_62				
Action/Comments					
Trim and thin trees to allow visibility of the ground and room to flood fight.

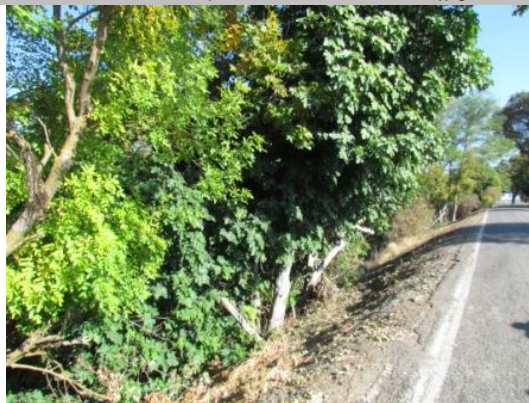
Photo 2 of 2 : pkazi\_s\_20140328\_666.jpg

Tree was blocking the visibility on the waterside of the levee looking upstream. This picture was taken during fall 2012 inspection.

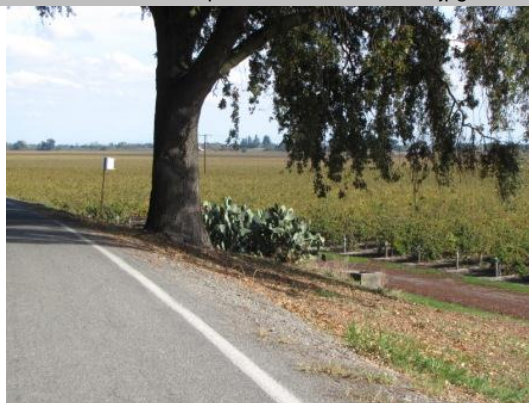
Photo 1 of 1 : pkazi\_s\_20140328\_660.jpg

View of landscaping along the landward slope.

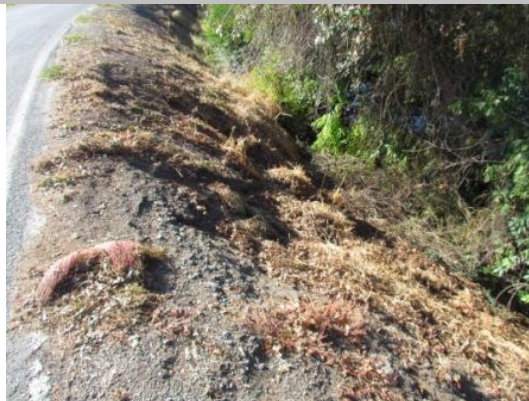
Photo 1 of 1 : pkazi\_s\_20140328\_640.jpg

Slope instability was found on the waterside of the levee looking downstream.

LM Start	6.61	Rating **	M	Issue No.	43
LM End	6.61	Issue Type +	Ma	Location *	WS
Category	Earthen Levee			GPS Latitude/Longitude	
				Start	End
Item	Slope Stability			38.392172 °	38.392172 °
				-121.538065 °	-121.538065 °
DWR ID	DWR_RD0150_03_f_2012_43				
Action/Comments					
Repair slope instability.

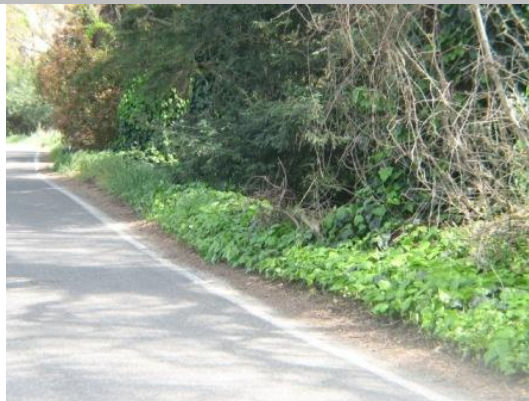
Photo 1 of 1 : pkazi\_s\_20140328\_629.jpg

Landscaping on landward slope blocking view from LM 6.87 to 6.95

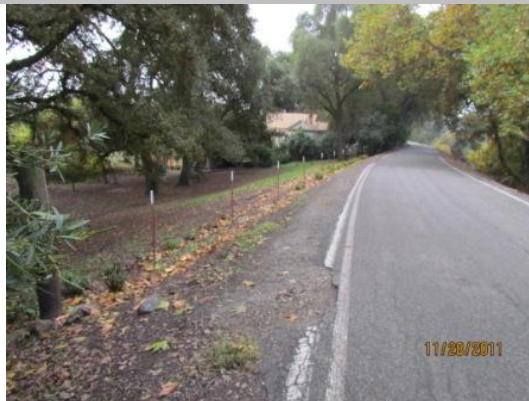
Photo 1 of 1 : pkazi\_s\_20140328\_620.jpg

Fence was found on the landside of the levee looking downstream.

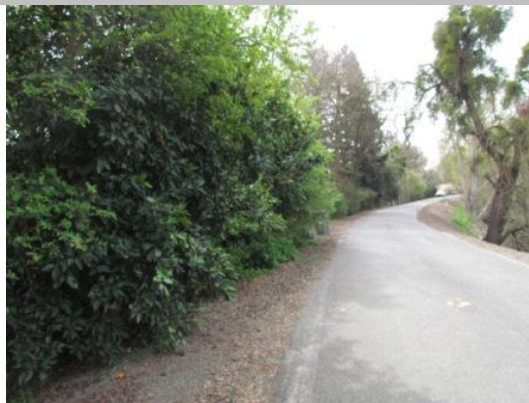
Photo 1 of 1 : pkazi\_s\_20140328\_703.jpg

LM Start	6.98	Rating **	M	Issue No.	933
LM End	7.04	Issue Type +	En	Location *	LS
Category	Earthen Levee			GPS Latitude/Longitude	
				Start	End
Item	Vegetation			38.396187 °	38.396989 °
				-121.536180 °	-121.535151 °
DWR ID	DWR_RD0150_03_s _ 2012_933				
Action/Comments					
Landscaping Inspector Comments: Landscaping has been maintained better, but some obstructions still exist.

View of the landscape on the landside shoulder of the levee looking downstream.

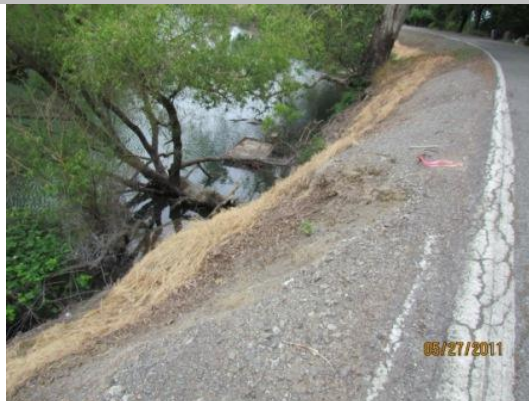
Photo 1 of 4 : pkazi\_s\_20140328\_661.jpg

LM Start	7.02	Rating **	M	Issue No.	61
LM End	7.02	Issue Type +	Ma	Location *	WS
Category	Earthen Levee			GPS Latitude/Longitude	
				Start	End
Item	Erosion / Bank Caving			38.396655 °	38.396655 °
				-121.535485 °	-121.535485 °
DWR ID	DWR_RD0150_03_s_2012_61				
Action/Comments					
Note and monitor erosion site.

Updated erosion site picture on the waterside slope of the levee looking upstream during Spring 2011 inspection.

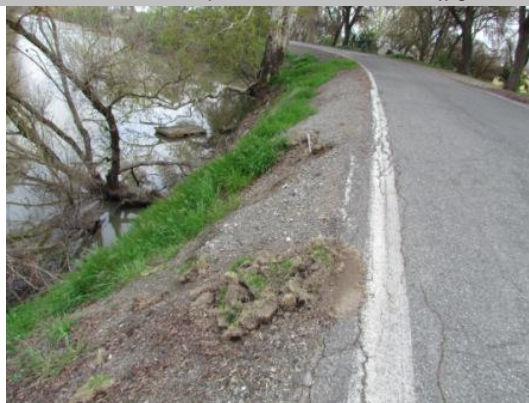
Photo 3 of 4 : pkazi\_s\_20140328\_663.jpg

Erosion on the waterside of the levee looking upstream. This picture was taken during spring 2012 inspection.

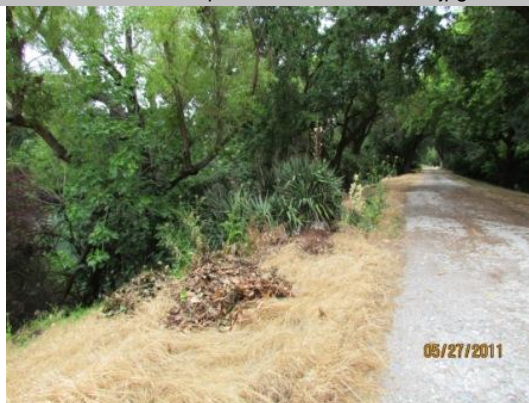
Photo 1 of 1 : pkazi\_s\_20140328\_668.jpg

LM Start	7.39	Rating **	M	Issue No.	64
LM End	7.39	Issue Type +	En	Location *	WS
Category	Earthen Levee			GPS Latitude/Longitude	
				Start	End
Item	Vegetation			38.401481 °	38.401481 °
				-121.536876 °	-121.536876 °
DWR ID	DWR_RD0150_03_s_2012_64				
Action/Comments					
Landscaping

Landscaping on the waterside of the levee. The picture was taken from the crown looking upstream.

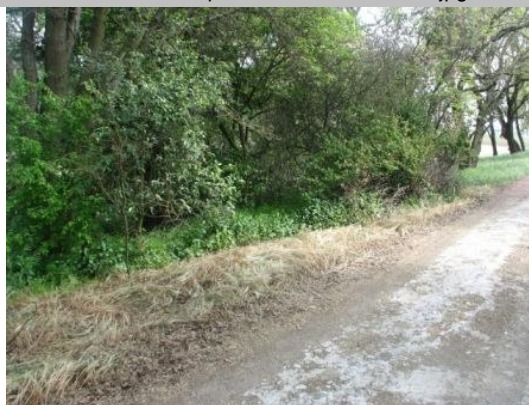
Photo 1 of 2 : pkazi\_s\_20140328\_631.jpg

LM Start	7.42	Rating **	M	Issue No.	32
LM End	7.47	Issue Type +	En	Location *	LS
Category	Earthen Levee			GPS Latitude/Longitude	
				Start	End
Item	Vegetation			38.401738 °	38.402296 °
				-121.537127 °	-121.537678 °
DWR ID	DWR_RD0150_03_s_2012_32				
Action/Comments					
Landscaping

Landscaping on landward slope blocking view from LM 7.42 to 7.47

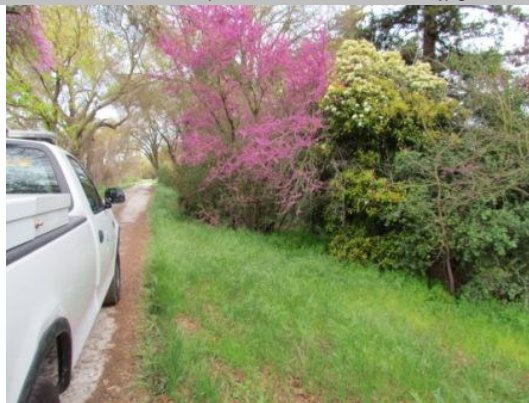
Photo 2 of 2 : pkazi\_s\_20140328\_632.jpg

Vegetation on the landside of the levee looking upstream. This picture was taken during spring 2012 inspection.

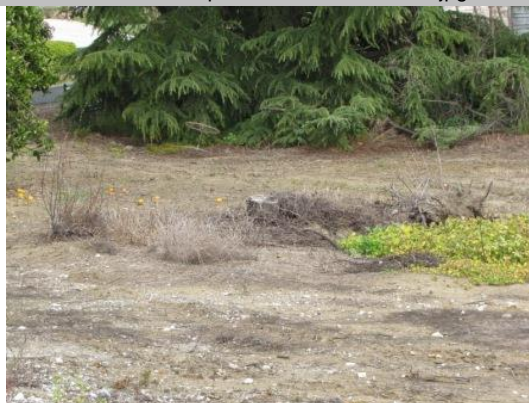
Photo 1 of 1 : pkazi\_s\_20140328\_667.jpg

LM Start	7.50	Rating **	N	Issue No.	63
LM End	7.50	Issue Type +	Ma	Location *	LS
Category	Earthen Levee			GPS Latitude/Longitude	
				Start	End
Item	Trim / Thin Trees			38.402779 °	38.402779 °
				-121.538197 °	-121.538197 °
DWR ID	DWR_RD0150_03_s _ 2012_63				
Action/Comments					
Tree stumps.

View of a tree stump on the landward slope.

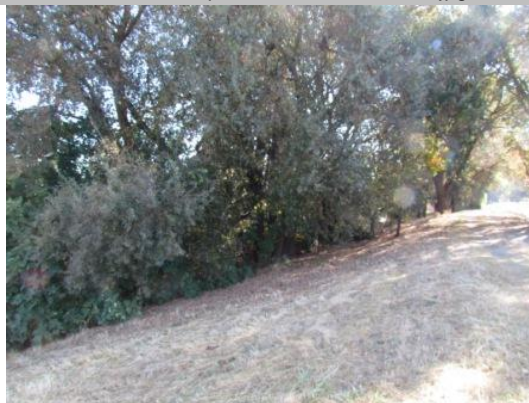
Photo 1 of 1 : pkazi\_s\_20140328\_704.jpg

LM Start	7.58	Rating **	M	Issue No.	934
LM End	7.58	Issue Type +	En	Location *	LS
Category	Earthen Levee			GPS Latitude/Longitude	
				Start	End
Item	Vegetation			38.403566 °	38.403566 °
				-121.538886 °	-121.538886 °
DWR ID	DWR_RD0150_03_s _ 2012_934				
Action/Comments					
Landscaping

Landscaping was blocking the visibility on the landside of the levee looking downstream.

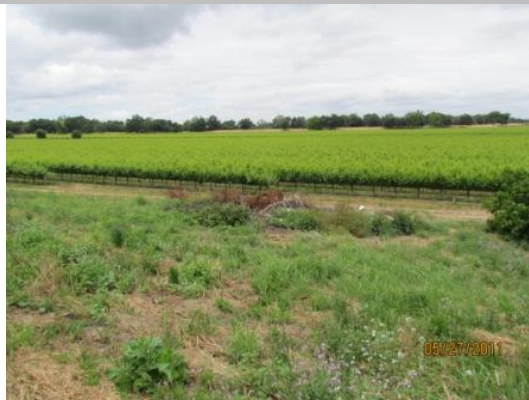
Photo 1 of 3 : pkazi\_s\_20140328\_705.jpg

LM Start	7.60	Rating **	M	Issue No.	935
LM End	7.60	Issue Type +	Ma	Location *	LS
Category	Earthen Levee			GPS Latitude/Longitude	
				Start	End
Item	Encroachments			38.403795 °	38.403795 °
				-121.539205 °	-121.539205 °
DWR ID	DWR_RD0150_03_s _ 2012_935				
Action/Comments					
Prunings

Prunings located on the toe of landward side of the levee. The picture was taken from the crown looking upstream.

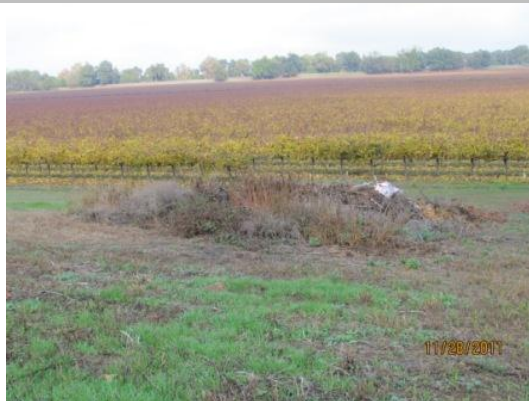
Photo 2 of 3 : pkazi\_s\_20140328\_706.jpg

Prunings were found on the landside of the levee looking upstream. This picture was taken during fall 2011 inspection.

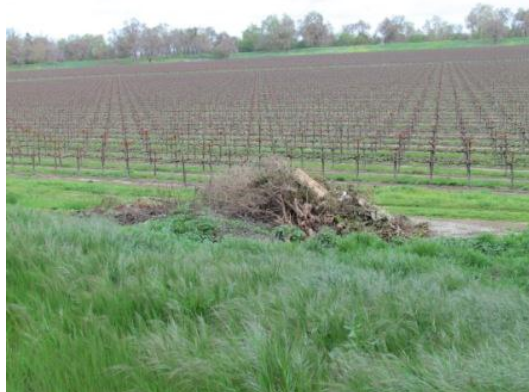
Photo 3 of 3 : pkazi\_s\_20140328\_707.jpg

LM Start	7.60	Rating **	M	Issue No.	935 (cont)	
LM End	7.60	Issue Type +	Ma	Location *	LS	
Category	Earthen Levee			GPS Latitude/Longitude		
				Start		End
Item	Encroachments			38.403795 °	38.403795 °	
				-121.539205 °	-121.539205 °	
DWR ID	DWR_RD0150_03_s _ 2012_935					
Action/Comments						
Prunings

Prunings were found on the landside of the levee looking upstream.

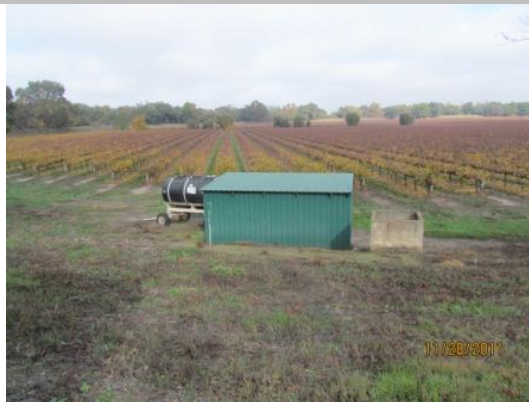
Photo 1 of 1 : pkazi\_s\_20140328\_621.jpg

LM Start	7.82	Rating **	M	Issue No.	16
LM End	7.82	Issue Type +	En	Location *	LS
Category	Earthen Levee			GPS Latitude/Longitude	
				Start	End
Item	Encroachments			38.405342 °	38.405342 °
				-121.542553 °	-121.542553 °
DWR ID	DWR_RD0150_03_s _ 2012_16				
Action/Comments					
Equipment

Equipment was found on the landside of the levee looking upstream.

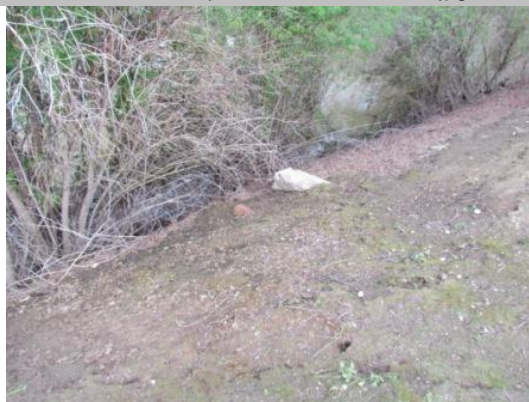
Photo 1 of 1 : pkazi\_s\_20140328\_686.jpg

LM Start	8.05	Rating **	M	Issue No.	87
LM End	8.05	Issue Type +	En	Location *	WS
Category	Earthen Levee			GPS Latitude/Longitude	
				Start	End
Item	Encroachments			38.408342 °	38.408342 °
				-121.541580 °	-121.541580 °
DWR ID	DWR_RD0150_03_s_2012_87				
Action/Comments					
Pipe					
Inspector Comments: An abandoned pipe.

An abandoned pipe was found on the waterside of the levee looking upstream.

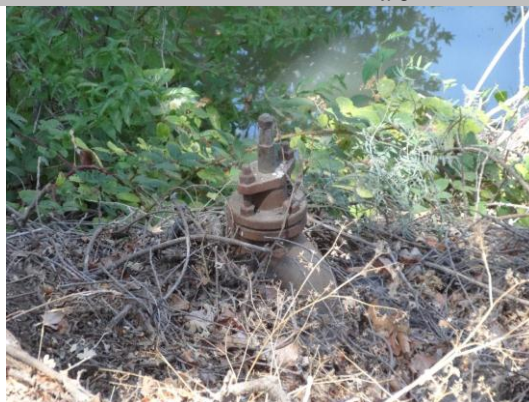
Photo 1 of 1 : UCIP\_2107.jpg

LM Start	8.35	Rating **	M	Issue No.	45
LM End	8.35	Issue Type +	En	Location *	LS
Category	Supplemental			GPS Latitude/Longitude	
				Start	End
Item	DWR UCIP Field Study			38.408619 °	38.408619 °
				-121.536768 °	-121.536768 °
DWR ID	DWR_RD0150_03_s_2014_45				
Action/Comments					
Inspector Comments: FS_ID:19744					
EP_NO: N/A					
Repair Type:					
Crossing Status:					
UCIP Comments: - needs proper abandonment pile structure in stream may need proper abandonment					
FIELD_STRUCT_DESC: 10-inch abandoned steel pipe through the levee, 13.8 feet below the crown. Gate valve on the waterward end.					
Service pole with guy wire on the landward slope. (A. Colby) O&M Manual SAC 112, March 1957.					
FS Date: 8/23/2013

WS view: abandoned gate valve found on levee slope.

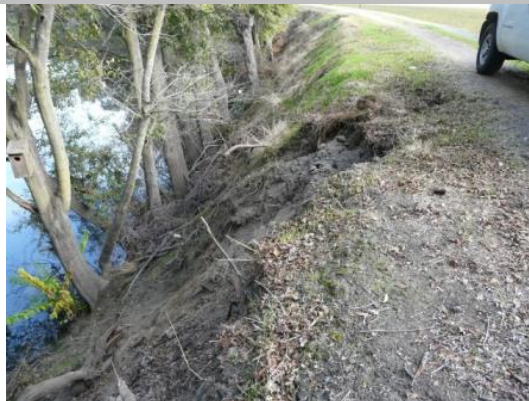
Photo 1 of 1 : pkazi\_s\_20140328\_670.jpg

LM Start	8.46	Rating **	M	Issue No.	66
LM End	8.46	Issue Type +	Ma	Location *	WS
Category	Earthen Levee			GPS Latitude/Longitude	
				Start	End
Item	Erosion / Bank Caving			38.407960 °	38.407960 °
				-121.534898 °	-121.534898 °
DWR ID	DWR_RD0150_03_s _ 2012_66				
Action/Comments					
Note and monitor erosion site.

Repair erosion on waterward slope near shoulder at LM 8.46.

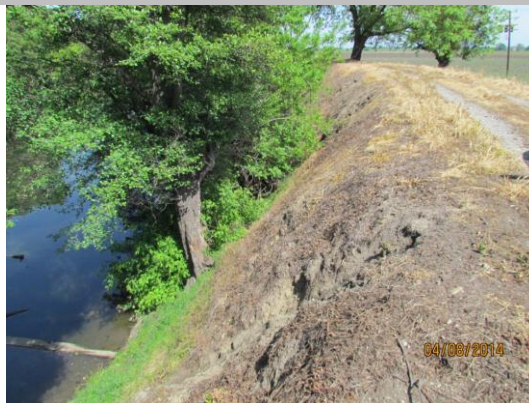
Photo 1 of 3 : pkazi\_s\_20140408\_081.jpg

LM Start	8.48	Rating **	M	Issue No.	67
LM End	8.48	Issue Type +	Ma	Location *	WS
Category	Earthen Levee			GPS Latitude/Longitude	
				Start	End
Item	Erosion / Bank Caving			38.407958 °	38.407958 °
				-121.534583 °	-121.534583 °
DWR ID	DWR_RD0150_03_s _ 2012_67				
Action/Comments					
Note and monitor erosion site.

Updated picture of the slope instability on the waterside shoulder looking upstream during spring 2014 inspection.

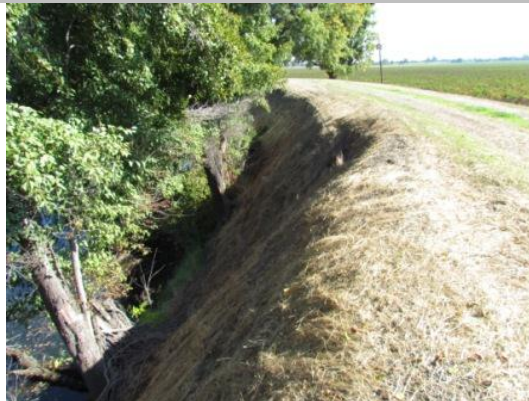
Photo 2 of 3 : pkazi\_s\_20140328\_672.jpg

Slope instability was found on the waterside shoulder of the levee looking upstream. This picture was taken during fall 2012 inspection.

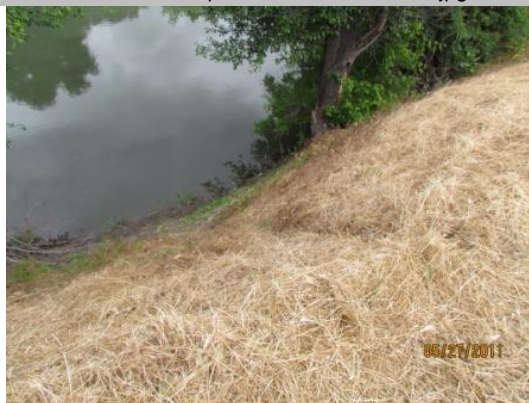
Photo 3 of 3 : pkazi\_s\_20140328\_671.jpg

LM Start	8.48	Rating **	M	Issue No.	67 (cont)	
LM End	8.48	Issue Type +	Ma	Location *	WS	
Category	Earthen Levee			GPS Latitude/Longitude		
				Start	End	
Item	Erosion / Bank Caving			38.407958 °	38.407958 °	
				-121.534583 °	-121.534583 °	
DWR ID	DWR_RD0150_03_s _ 2012_67					
Action/Comments						
Note and monitor erosion site.

Slope instability on the waterside slope of the levee. The picture was taken from the crown looking upstream.

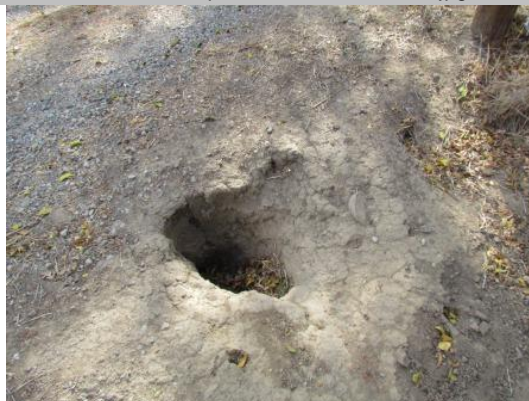
Photo 2 of 2 : pkazi\_s\_20140328\_688.jpg

Updated picture of the rodent hole on the waterside shoulder of the levee looking downstream during the fall 2013 inspection.

LM Start	8.52	Rating **	M	Issue No.	89
LM End	8.52	Issue Type +	Ma	Location *	WS
Category	Earthen Levee			GPS Latitude/Longitude	
				Start	End
Item	Animal Control			38.408153 °	38.408153 °
				-121.533980 °	-121.533980 °
DWR ID	DWR_RD0150_03_s _ 2012_89				
Action/Comments					
Exterminate rodents and backfill and compact or grout burrows.

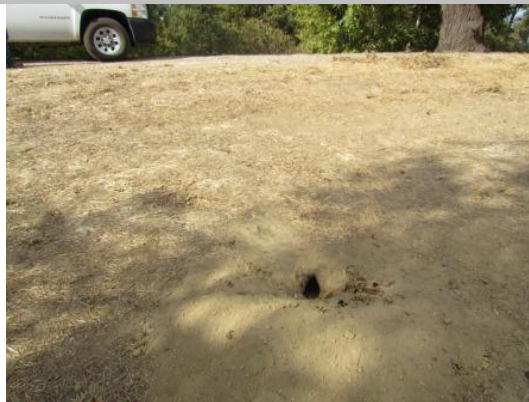
Photo 1 of 1 : pkazi\_s\_20140328\_700.jpg

LM Start	8.62	Rating **	M	Issue No.	120
LM End	8.62	Issue Type +	Ma	Location *	LS
Category	Earthen Levee			GPS Latitude/Longitude	
				Start	End
Item	Animal Control			38.409287 °	38.409287 °
				-121.532718 °	-121.532718 °
DWR ID	DWR_RD0150_03_f _ 2013_120				
Action/Comments					
No rodents visible, but rodent burrows visible; need to backfill and compact or grout burrows.

A rodent hole was found on the landside slope of the levee. The picture was taken from the landside toe looking towards the crown during fall 2013 inspection.

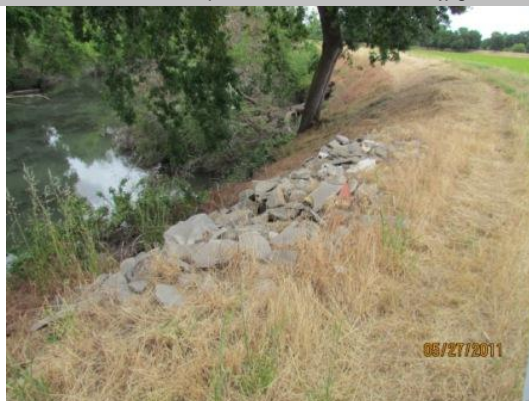
Photo 1 of 1 : pkazi\_s\_20140328\_613.jpg

LM Start	8.87	Rating **	M	Issue No.	7
LM End	8.87	Issue Type +	Ma	Location *	WS
Category	Earthen Levee			GPS Latitude/Longitude	
				Start	End
Item	Encroachments			38.411593 °	38.411593 °
				-121.529143 °	-121.529143 °
DWR ID	DWR_RD0150_03_s _ 2012_7				
Action/Comments					
Debris

Broken concrete pipe was left on the waterside slope of the levee. The picture was taken from the crown looking upstream.

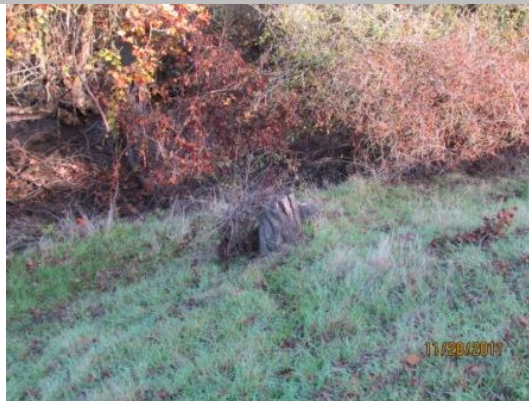
Photo 1 of 1 : pkazi\_s\_20140328\_659.jpg

LM Start	9.38	Rating **	N	Issue No.	59
LM End	9.38	Issue Type +	Ma	Location *	WS
Category	Earthen Levee			GPS Latitude/Longitude	
				Start	End
Item	Trim / Thin Trees			38.413268 °	38.413268 °
				-121.525929 °	-121.525929 °
DWR ID	DWR_RD0150_03_s _ 2012_59				
Action/Comments					
Tree stumps.

A tree stump was found on the waterside of the levee looking upstream.

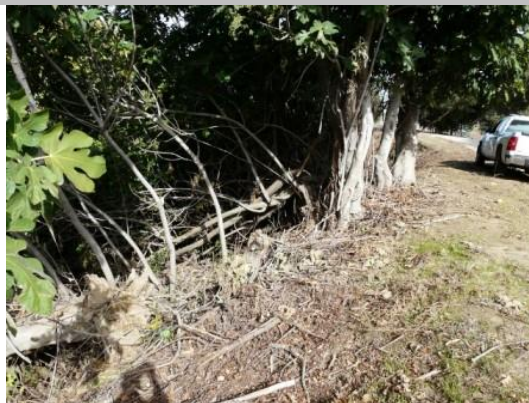
Photo 1 of 1 : pkazi\_s\_20140328\_677.jpg

LM Start	9.51	Rating **	M	Issue No.	73
LM End	9.51	Issue Type +	Ma	Location *	WS
Category	Earthen Levee			GPS Latitude/Longitude	
				Start	End
Item	Trim / Thin Trees			38.413169 °	38.413169 °
				-121.523707 °	-121.523707 °
DWR ID	DWR_RD0150_03_s _ 2012_73				
Action/Comments					
Trim and thin trees to allow visibility of the ground and room to flood fight.

Thin/trim trees to allow for visibility of top 20' of waterward slope at LM 9.51.

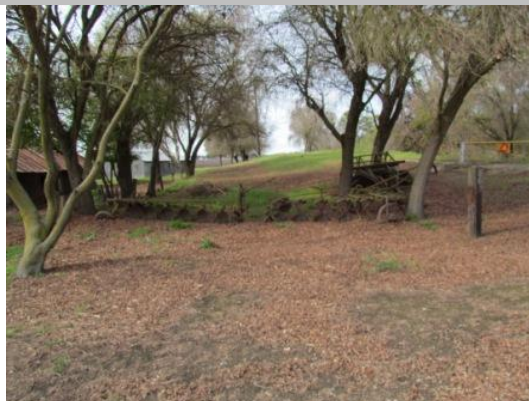
Photo 1 of 1 : pkazi\_s\_20140328\_710.jpg

LM Start	9.56	Rating **	M	Issue No.	950
LM End	9.56	Issue Type +	En	Location *	LS
Category	Earthen Levee			GPS Latitude/Longitude	
				Start	End
Item	Encroachments			38.413560 °	38.413560 °
				-121.522936 °	-121.522936 °
DWR ID	DWR_RD0150_03_s _ 2012_950				
Action/Comments					
Equipment

Equipment was found on the landside of the levee looking downstream.
